XVI ERIAC DECIMOSEXTO ENCUENTRO REGIONAL IBEROAMERICANO DE CIGRÉ

Comité de Estudio A1 - Máquinas Eléctricas Rotativas

RETURN OF EXPERIENCE FROM CONTINUOUS PD MONITORING OF ROTATING MACHINES

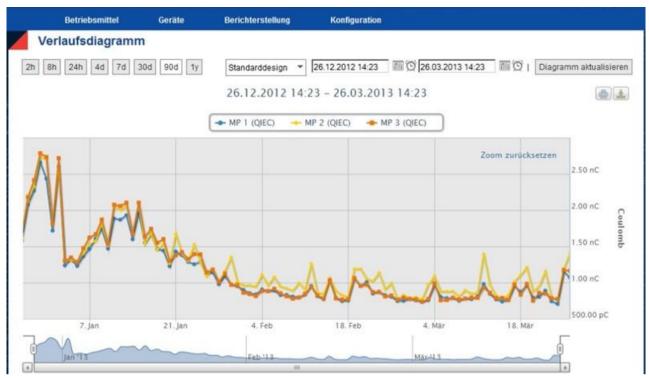
Fig. 2. Three phase PD trend diagram

The on-line PD monitoring system was installed during the outage and it started immediately collecting data when the generator was put back into operation. It can be seen in the three phase PD trend diagram (Fig. 2) that the PD level decreases after start up. After the conditioning time of two months a data processing was performed with the support of an automated pattern classification system. The accuracy of automatic data evaluation depends on the efficiency of preliminary separation of different PD sources and on effective suppression of disturbances and background noise. To achieve this, synchronous multi-channel evaluation techniques were applied [3].

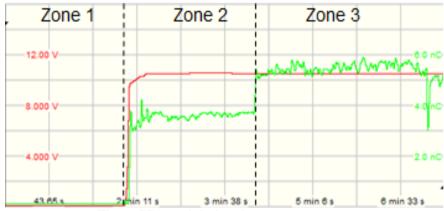
Fig. 6. PD trend during the start-up process

The start-up process of Generator 2 was monitored and in Fig. 6 the charge variation (green curve) during the increase of the voltage (red curve) is shown. The increase of PD activity can be correlated to the changes in load conditions (zones 2 and 3). The PD value increased from a few pC (background noise level) to 3.7 nC (Zone 2) and then to 5.7 nC (Zone 3) when the machine was at full load. The displayed voltage value is measured at the input to the acquisition unit. To get the real voltage value on the bus bar these values have to be multiplied by a divider factor of about 1000.
